**ANNUAL REVIEW FOR 2017  
OF THE CAPE MAY POINT, NJ MUNICIPAL BEACHES**

PREPARED FOR: THE BOROUGH OF CAPE MAY POINT  
215 LIGHTHOUSE AVENUE  
CAPE MAY POINT, NJ 08212

PREPARED BY: STOCKTON UNIVERSITY COASTAL RESEARCH CENTER  
30 WILSON AVENUE  
PORT REPUBLIC, NJ 08241

June 1, 2017

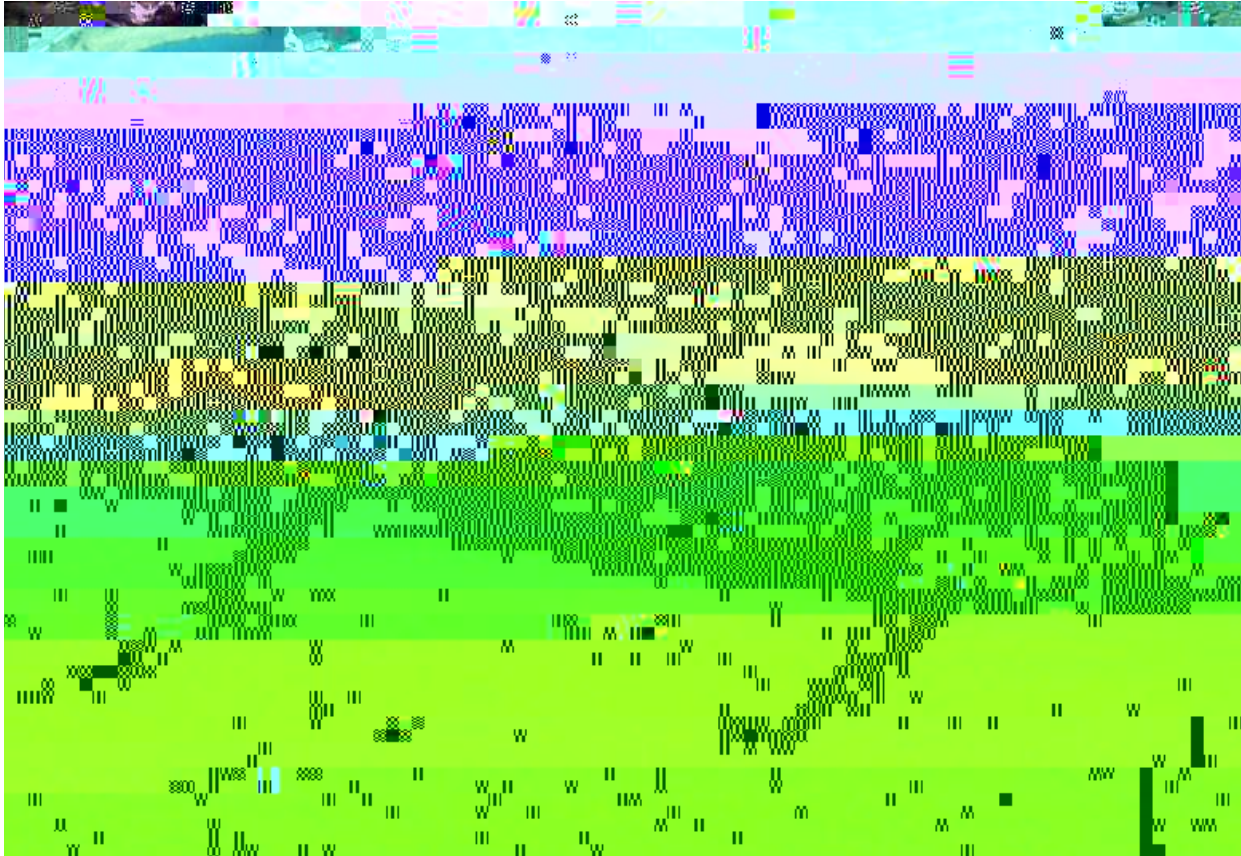
The photo above taken on September 1998 is presented to remind everyone what the Cape May Borough shoreline once looked like where storms routinely broke through at Lighthouse Avenue, rocks were the final line of defence between Lighthouse and Lehigh Avenues, and much of the remaining shoreline was wet to the dunes where a steep scarp meant that erosion was still at work reducing Cape May Point since the days of the Wanamakers as the earliest home builders in Sea Grove Village.
