**FINAL REPORT FOR 2021
ON THE CONDITION OF THE MUNICIPAL BEACHES
IN**

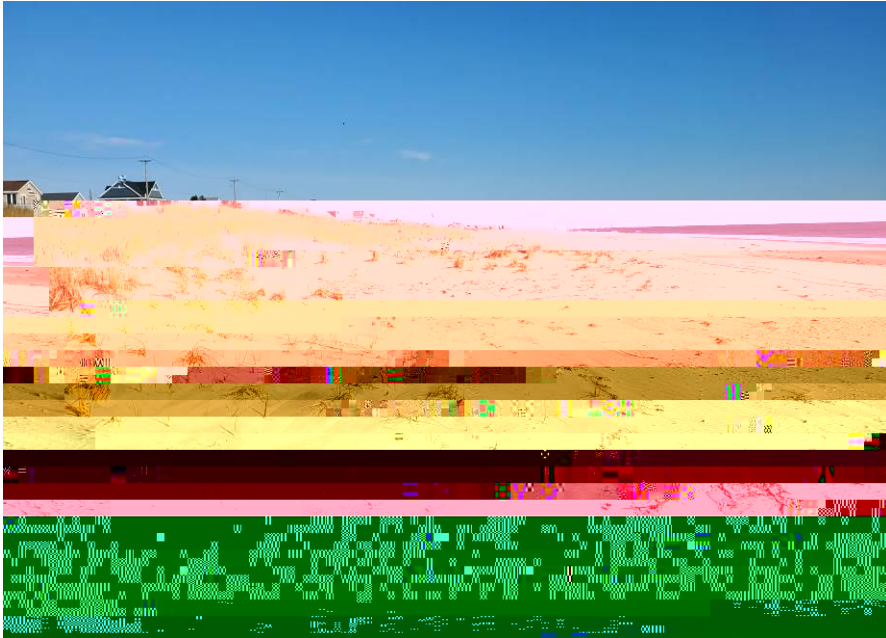
14a. December 15, 2020

Photograph 14a is a view to the north at the seaward toe of the dunes across the beach showing the extent of sand accumulation. There is far more sand present than was on the site prior to the federal project completion.
