**2020 FINAL REPORT - TO THE CITY OF NORTH WILDWOOD
ON THE
CONDITION OF THE CITY BEACHES**

Introduction:

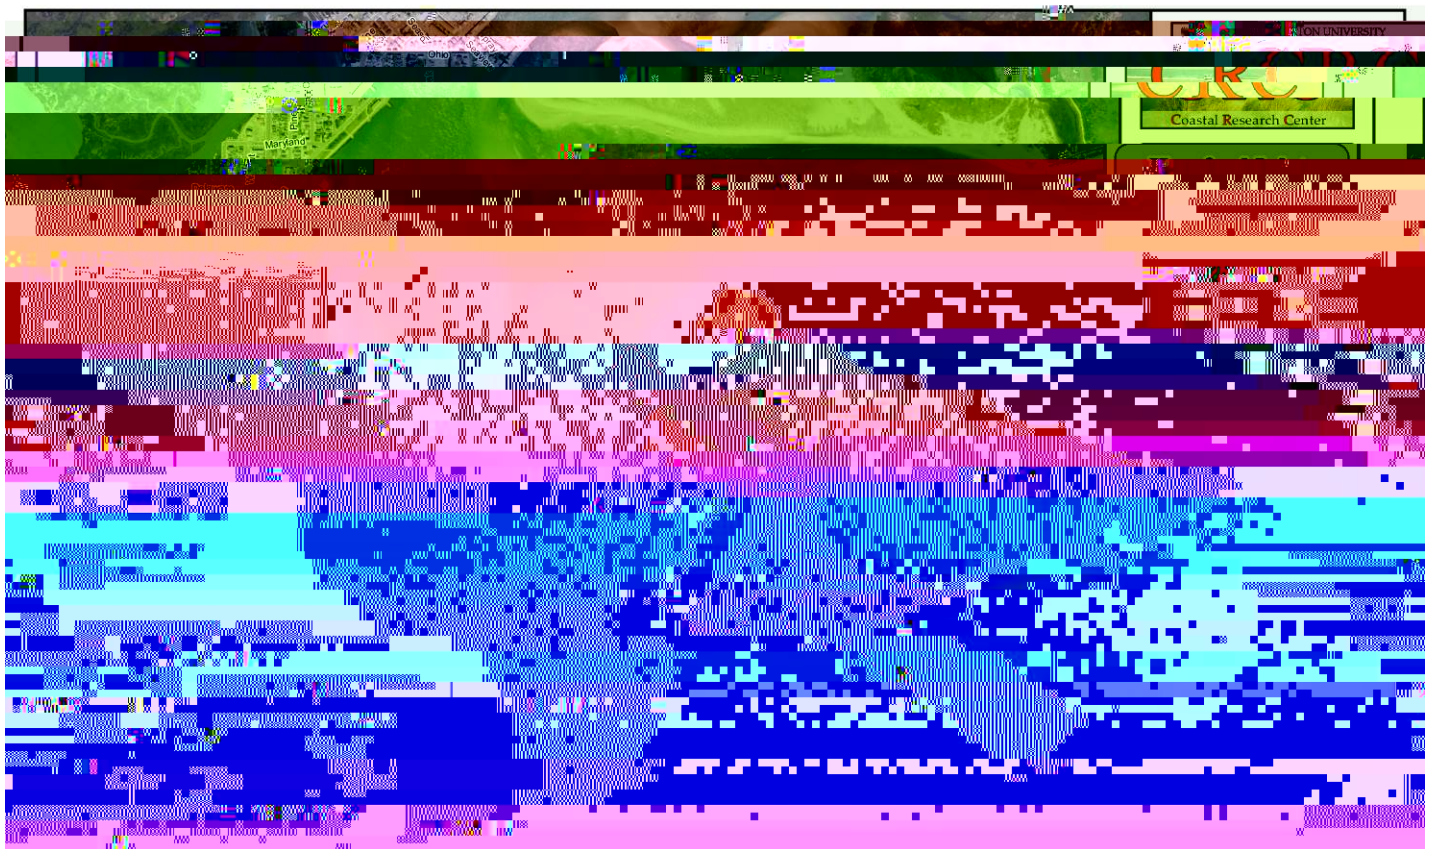
Figure 29. The fall 2020 borrow zone survey data was compared to the last NJDEP funded Hereford Inlet survey covering a wider area to determine change in sand supplies and locations since fall 2018. The multi-assigned authorized borrow zones are outlined for both federal and NJDEP source areas with the NJDEP sites A, B and C on the south end of the entire site. The best accumulation has occurred in DEP sites B and C where the net gain was 137,120 yards of sand since 2018. NJDEP zone A has done better than the data indicates because the color-blanked hatched area could not be surveyed in 2020 because of extremely shallow water within the hatched area. The deep red zone cutting through the DEP A and USACE A1 zones is the new ebb-tidal channel generated by the closure of the one shown in the 2019 air photograph as background that existed close to the North Wildwood inlet shoreline. The NJDEP C zone blank hatched area was not surveyed in 2018 as it was too far from shore and in deep water beyond the allowed dredging depths. That segment remains deep as of 2020 (Figure 28).

The City requested a survey of the State and Federally authorized Hereford Inlet sand borrow zone located in the ebb tidal shoals of the inlet approximately 1,500 feet northeast of the inlet jetty and Kennedy Boulevard. This was completed November 24, 2020 under ideal surf and wind wave conditions. The digital elevation model of the bathymetry shows extensive sand deposition in the southern section of the borrow zone where any potential supply for North Wildwood would be extracted. A significant inlet's medial ebb channel produced a deeper trough through the entire zone area since 2018 data was obtained, some parts of the site for sand supplies. Most of the sediment has accumulated between this new ebb channel and the North Wildwood shoreline on the inlet. In fact, the high tide during the day of the survey, the 24-foot vessel was unable to continue out to sea along what had previously been a channel along the inlet beach and past the jetty tip. The water was less than 2 feet deep at high tide over 800 feet from the water's edge.
