Figure 1. NJBPN Profile Locations and 100 year storm beach dune susceptibility assessment results for Atlantic County, New Jersey

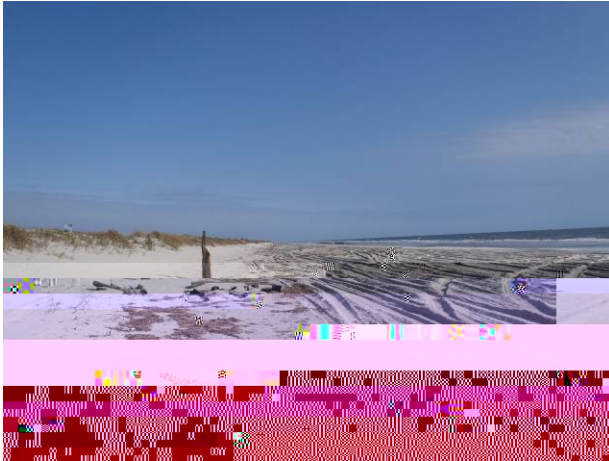
The photographs above were taken on October 26, 2012 (left) and November 11, 2012 (right). The dune on the left started from nothing in January 1993, and was washed flat by Sandy (right). It is likely that the posts in the right picture date from the original post storm effort to re create the dune along this open space beach.

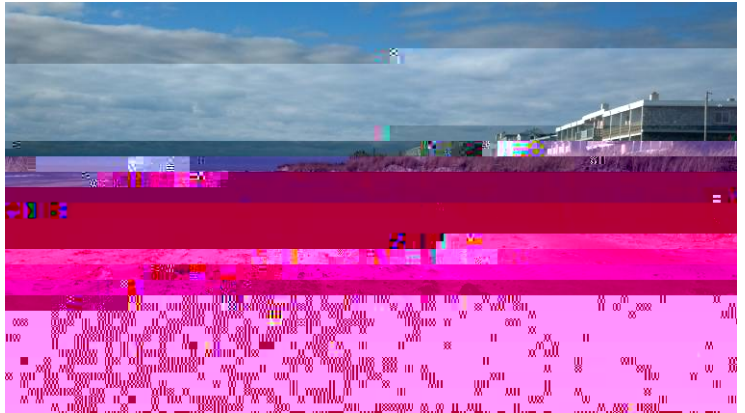
The photographs above were taken on October 26, 2012 (left) and November 3, 2012 (right). The seaward slope

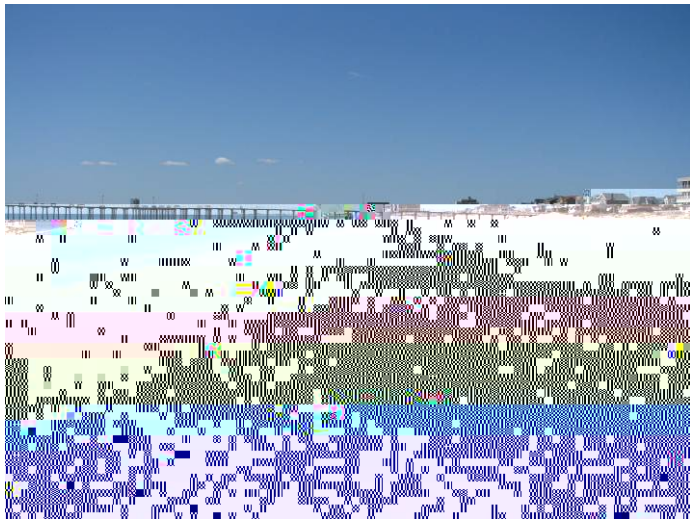
The photographs above were taken on April 13, 2012 (left) and November 6, 2012 (right). Dorset Avenue in Ventnor City also is located in the middle of the Federal project with excellent retention of the sand placed in 2004.
