December 12, 2012

The Richard Stockton College of NJ Coastal Research Center (CRC) has initiated a post storm survey and as

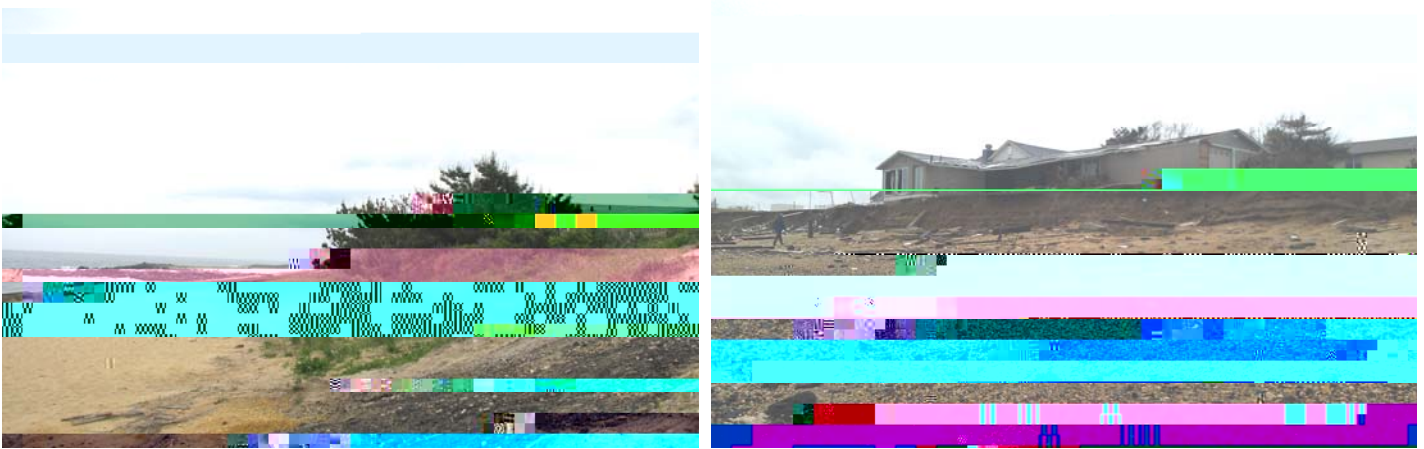
The photographs above were taken on May 13, 2012 (left) and November 13, 2012 (right).

Figure 3. This site is located on the highest point along the bluff shoreline and in the past, has had very little sub aerial beach as this community was not included in the Federal beach nourishment projects. Prior to Hurricane Sandy the private properties were separated from the shoreline by a bulkhead and rock revetment which rises 12 feet in elevation and was un damaged. However, waves apparently broke over the rock revetment, attacked upper un armored bluff sediments and pushed the edge back 40 feet. The waves reached both homes either side of the street destroying both and removing a third of the building lot in the process. A small wedge of sand was observed in the corner created between the revetment and the south groin in this cell. The beach in front of the profile was virtually unchanged.
